## IV. Problem Definition

### **Little Anderson Creek**

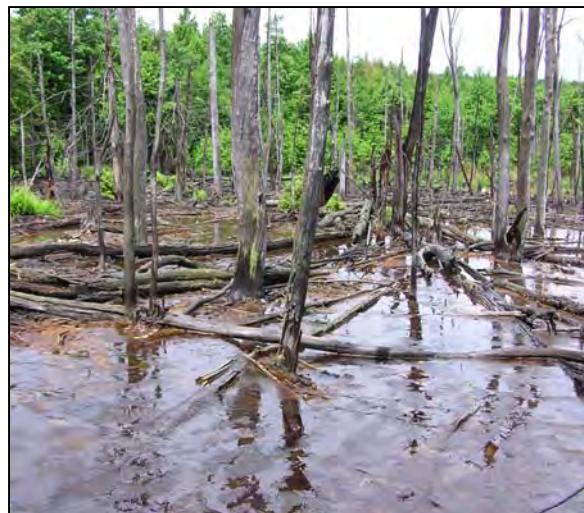
Vegetation appeared to be impaired by acidic groundwater conditions at numerous areas leading to the detention basins and can be observed as areas of dead, withered, or nonexistent plant life. A very large kill zone developed where there are AMD discharges on the adjacent property, creating a severely degraded wetland. Green and brown filamentous algae abounds. It is very difficult to estimate how much water is being produced within the degraded wetland. It appears that most of the AMD surfaces are near the toe of the mine spoil. There is also a large pond of AMD-polluted water located at the toe of the spoil. The depth of

*Large “kill zone” caused by AMD seeping out immediately downslope of a large surface mine known as the Smouse Strip, located on UNT-LA 4.3.*

Remediating the AMD from this tributary is a key to reducing pollution to UNT-LA 4.3, upper Little Anderson Creek, and Anderson Creek. In particular, the Smouse surface mine discharges must be remediated to bring the tributary back to a point where it will support life and meet the TMDL goal. These discharges were not included in the TMDL because of a lack of proper flow and chemistry data. The loadings from the Smouse strip mine were included in the next downstream TMDL site, LA3. For the purpose of this study, recommendations for UNT LA2 (UNT-LA 4.3) will include the Smouse surface mine site discharges.

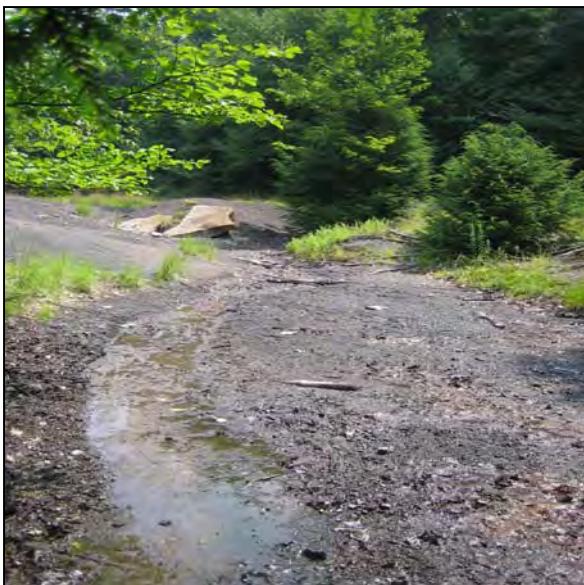
*Discharge from main entry of the Spencer mine at low-flow conditions.*

During the visual assessment, water was flowing out of the mine opening, but not at a high flow rate. Site conditions indicated that flows might be more significant at other times. A significant portion of the AMD from the mine appears to be infiltrating into the groundwater table and entering the Little Anderson Creek at stream level below the site. Several seep areas were located directly adjacent to the stream, at what appears to be the top of a clay layer located at that elevation. Field readings of 2.7 pH were noted during the assessment.

The Spencer mine is likely having a severe negative effect on Little Anderson Creek. How much so is very difficult to determine at this time. The discharge from the mine opening flows on the surface only at high groundwater periods. There appears to be a significant amount of water that also enters the groundwater table and appears as severely polluted seeps adjacent to Little Anderson Creek, downslope of the Spencer mine. During low flows, the AMD infiltrates completely into the ground and appears as a series of seeps directly adjacent to the stream. Locations of the seeps make it nearly impossible to accurately measure the total actual flows entering Little Anderson Creek.

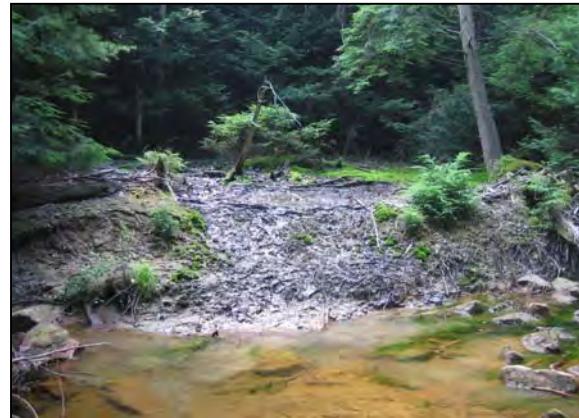
*Numerous, very low-pH seeps appear just above the streambed of Little Anderson Creek far below the elevation of the Spencer mine.*

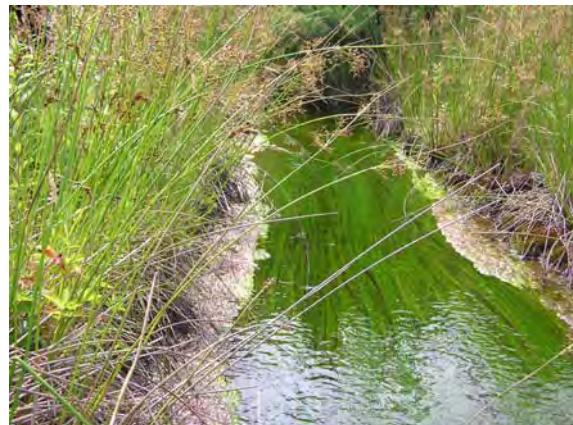
*The #2 priority Korb 4 discharge, draining from the abandoned Korb mine in Chestnut Grove.*

Korb mine is an underground clay mine (Scarlift Project Area XXXIX, Project Map 13), which is overlain by a coal seam. Some of the Korb mine underground clay mine has been remined by surface mining, but never reclaimed. Much of the clay mine workings remain. Of special concern is the fact that coal seams lie above the clay mines and in much of the area have subsided into the clay mine. This has created an especially troublesome condition because the coal and its overburden collapsed into the clay mine are known to produce high levels of acid and aluminum in their AMD. The Korb 4 discharge emanates from a deep ravine that is connected to the underground Korb mine workings, and was part of the reclamation effort after surface mining. This site was identified as priority #3 by the TMDL study. Collectively, all the discharges from the Korb mine were ranked as priority #4 by the Scarlift study. Korb 4 is identified as priority #2 by this study.

Because of the location and the water chemistry of the DMP-Korb4 discharge, one option may be a self-flushing limestone pond. This technology has recently been successfully demonstrated as a possible treatment option for AMD containing aluminum. This system is similar to an Upflow Limestone Pond but differs in it that automatically drains itself after imparting alkalinity to the acidic water and before aluminum has an opportunity to precipitate in the limestone. Other passive AMD treatment system options that utilize methods that can handle high aluminum discharges, such as Sulfate Reducing Bacteria Bioreactors, SAPS, Upflow Limestone Ponds, and other such systems, might also be

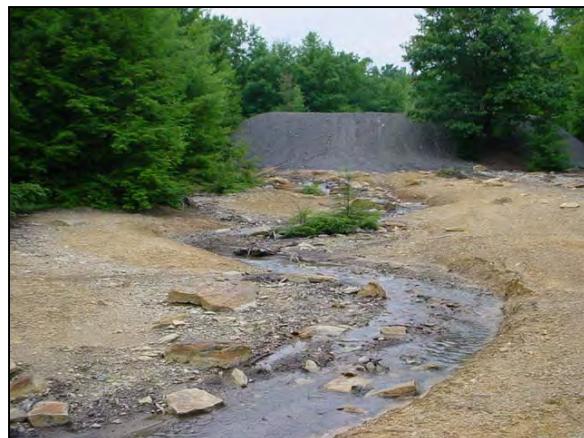
*Combined Korb2 and Korb3 discharges draining into an unnamed tributary to Anderson Creek (UNT AC8.2).*

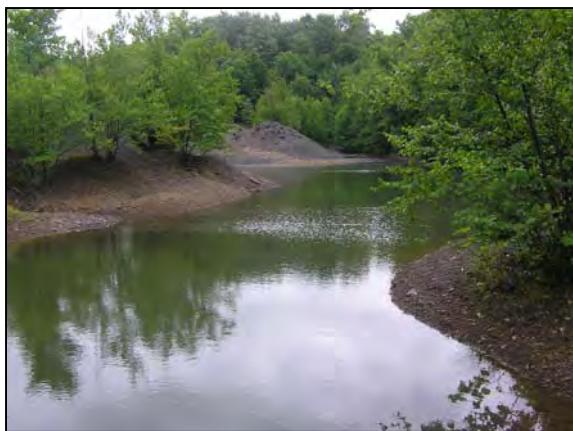
*Large flows of very acidic AMD and unreclaimed mine lands make reclamation very challenging for Drauckers1—the highest priority site in the Anderson Creek watershed.*

DMP-Drauckers1 flows through an unreclaimed area of mine spoil. It joins with the two previously mentioned intermittent streams draining the area near the intersection of Drauckers Bottom Road and Route 219 before combining with DMP-Drauckers2 in a large wetland area. The polluted water eventually combines with several other AMD sources and additional surface water to form UNT-LA 3.0, which eventually joins Little Anderson Creek.

Barring remining the site, several reclamation techniques could be considered for the site. Land reclamation at the site is highly desirable, considering that present conditions are causing the formation of AMD and sedimentation because of the lack of proper surface drainage and vegetation. In addition, treatment of DMP-Drauckers1 would greatly reduce the metals and acidity load entering UNT-LA3.0. There appears to be ample area for passive treatment. Because of the high acidity and high levels of aluminum in the discharge, passive treatment would likely necessitate the use of treatment systems able to handle those levels without the likelihood of premature failure. Modified Vertical Flow Systems, Sulfate Reducing Bioreactors, and

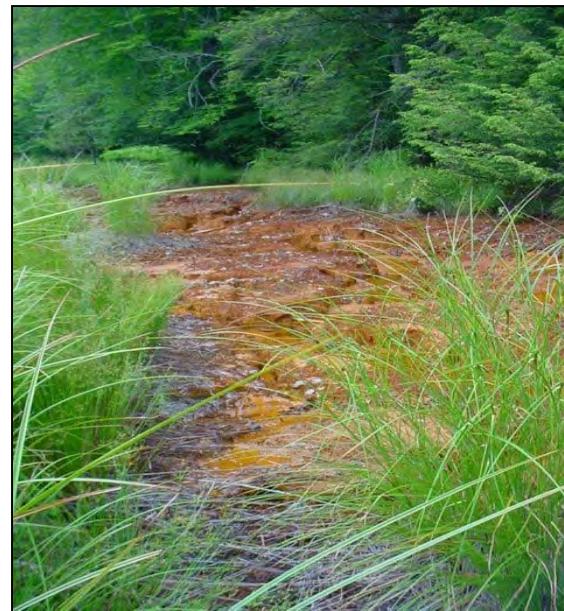
*Drauckers2 discharge prior to mixing with acidic groundwater.*

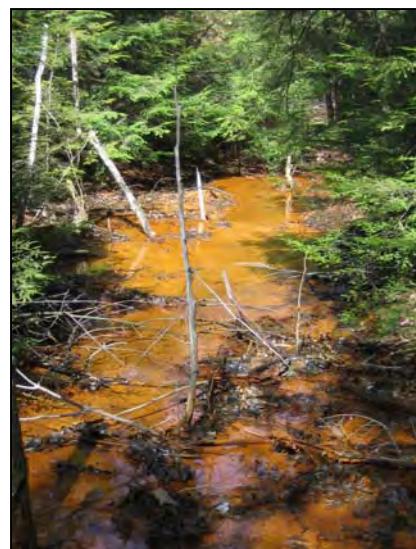
*Combined discharges at PAMP-LA 3.0-4.*

again, as the water traveled down gradient, and a relatively short distance, it gathered significantly more water and the field pH dropped to 3.3. Just upstream of the road, additional mine drainage enters from a surface-mined area to the south. Monitoring point PAMP-LA 3.0 - 4 is a combination of all the discharges upslope of the site.

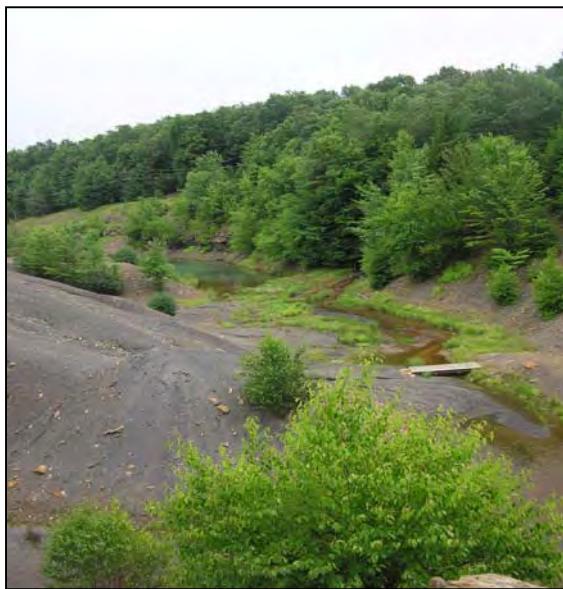
*The Wingert site is perhaps the worst abandoned surface mine site in the Anderson Creek watershed. Here an unnamed tributary flows off the highwall into the open pit.*

As with DMP- Drauckers1, perhaps the best option for the Wingert site is to explore the feasibility of remining the site and incorporating the reclamation of the land area during the remining. Conditions at this site are not conducive to remining, otherwise it would have likely already been remined as well. The strata associated with the coal seam also contain nodules of high sulfur and iron. These nodules can be seen throughout the spoil and within associated strata at the exposed highwalls. Like DMP-Drauckers1, remining and reclamation by cooperatively developing a reclamation plan between DEP and the mining company, using the best available techniques to reduce the possibility of creating additional pollution sources, would be the best option. Remining would strictly follow the agreed upon plan and the mining

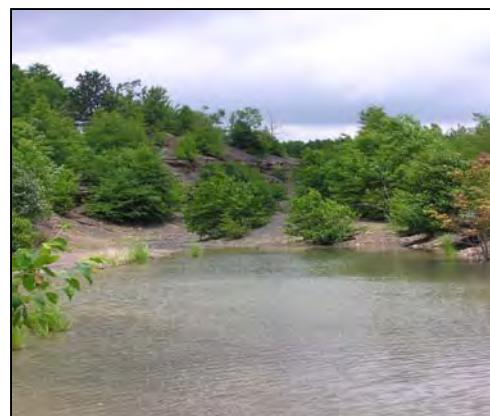
*Lack of proper surface drainage allows water to seep through poorly vegetated and un-reclaimed mine spoil.*

discharge disappears. A significant area of high, steep, un-vegetated mine spoil piles exists on the site. An open pit and highwall remain as well. As with DMP-Drauckers 1 and the Wingert site, a coal seam lies above the clay seam. Once again, the coal was simply discarded on site and mixed with the overburden material lying above the clay. And, like the other sites, the sulfur and iron nodules are present, and are visible in the highwall and mixed in with the spoil. During periods of high water, the pit of the surface mine collects water, allowing some of it to filter through the mine spoils, creating AMD that eventually reaches the stream. The monitoring point is located to measure the water that flows from the pit and into UNT-LA 3.0.

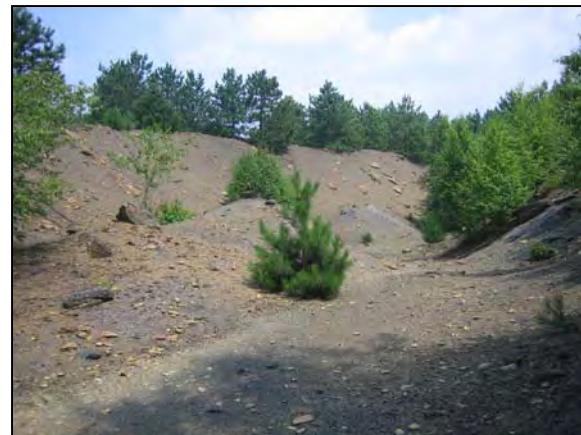
*Large abandoned mine site at headwaters of UNT-LA2.10 appears to serve as a major source for AMD during wet periods.*

This problem area is recommended for land reclamation and AMD treatment. It is recommended that land reclamation take place first, in order to reduce the amount of AMD being produced by the site. It is not known at this time whether remining is an option at this site, and investigation of that possibility should be pursued. If it is feasible, it may be possible to reclaim the site under a government financed construction contract (GFCC), which would reduce the cost of reclamation. As previously mentioned, re-contouring of the land to promote proper draining of surface water will help prevent that water from infiltrating into the mine spoil and creating higher volumes of AMD. In addition, the vegetation on the poorly reclaimed surface mine is very sparse and developing a thick mat of vegetation will also help to reduce water infiltration into the mine spoil, further reducing the flows of AMD. The addition of alkaline material into the spoil during reclamation will also serve to limit the production of AMD. Treatment of the AMD seeps is not recommended until land reclamation takes place.

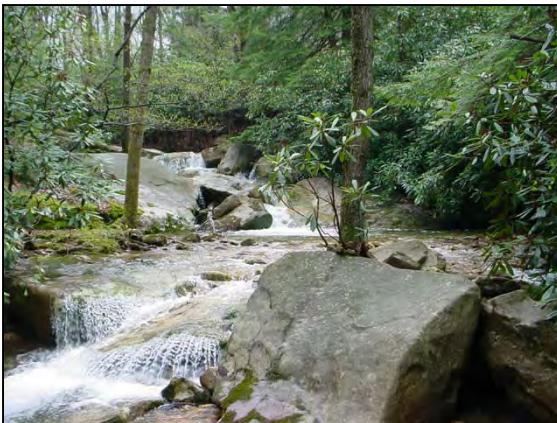
*Bear Run near its confluence with Anderson Creek.*

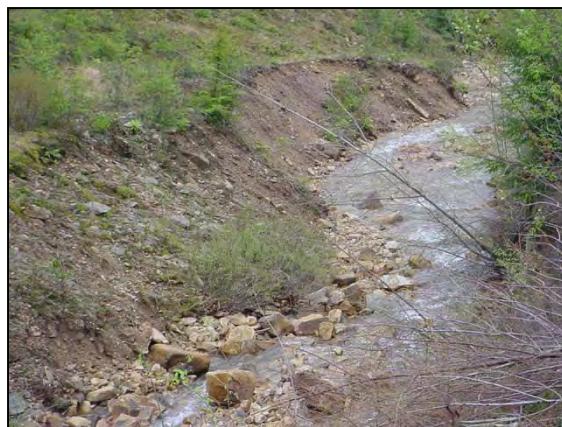
*Large erosion site on Bear Run, immediately below the water-supply reservoir.*

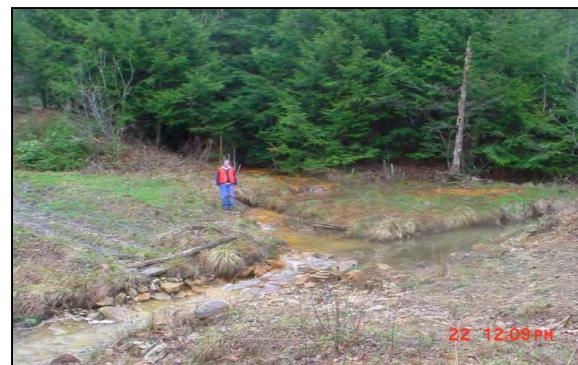
*The Widemire Discharge pollutes an unnamed tributary to Kratzer Run (UNT-KR2.15) with acid and aluminum.*

Aluminum and acidity levels are of most concern. During the study period, its flows fluctuated between 50 and 250 gpm. The TMDL for Widemire Discharge requires that a load allocation be made for OSL 220 [DMP-Widemire] for total iron and acidity (SRBC 2004).

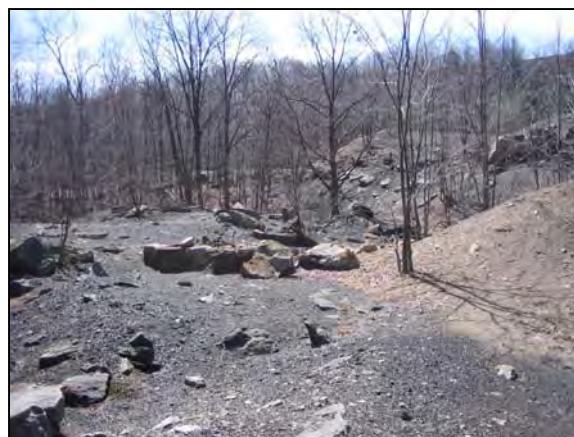
*Abandoned mine located above monitoring point PAMP-KR 1.45.*

Perhaps the best option for the Problem Area Monitoring Point KR 1.45 site is to explore the feasibility of remining the site and incorporating the reclamation of the land area during the remining. Conditions at this site are not likely conducive to remining, otherwise it would have already been remined. Implementing remining and reclamation by cooperatively developing a reclamation plan between DEP and the mining company, using the best available techniques to reduce the possibility of creating additional pollution sources, would be the best option. Remining would strictly follow the agreed-upon plan and the mining company would not be liable for any unforeseen circumstances should the pollution become worse. DEP would then assume responsibility for treating the water.

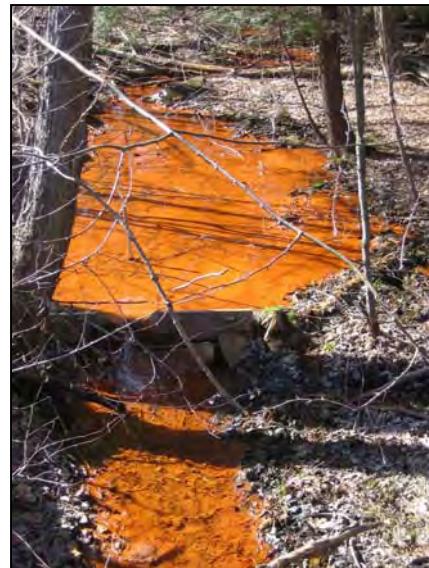
*DMP-879 is located adjacent to Route 879 below the mouth of Bilger Run on the north-side berm of the road.*

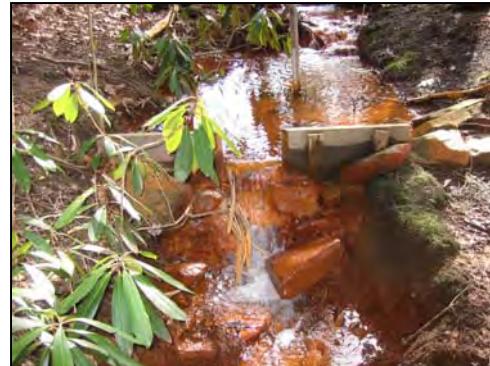
*DMP-Wildwood is located just upstream of Route 879 on Bilger Run.*

The Wildwood Discharge, named for a nearby local establishment, is located adjacent to the stream and forms a large, degraded wetland before discharging into the stream. There are some additional AMD seeps on the opposite side of the stream from the Wildwood Discharge. The seeps are smaller flows but do appear to have elevated levels of iron. Because the seeps were lower in flow, they were not considered a high priority and were not sampled during the monitoring period. Because of the steep topography on that side of the stream, it does not appear it would be feasible to treat the seeps without relocating them. They were considered a low priority for monitoring.

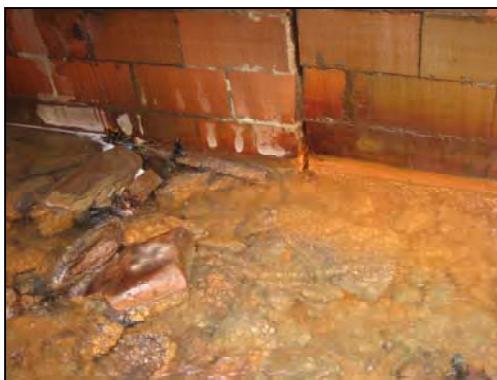
In addition to DMP-879, there are several other similar discharges impacting Kratzer Run. One of the most intriguing is actually coming from the base of the Route 879 Bridge over Bilger Run, at its confluence with Kratzer Run. The discharge comes from a large crack in the bridge pier. At the time it was assessed,

**AMD discharges from crack in Route 879 Bridge pier on Bilger Run.**
