## IV. Problem Definition

### **Little Anderson Creek**

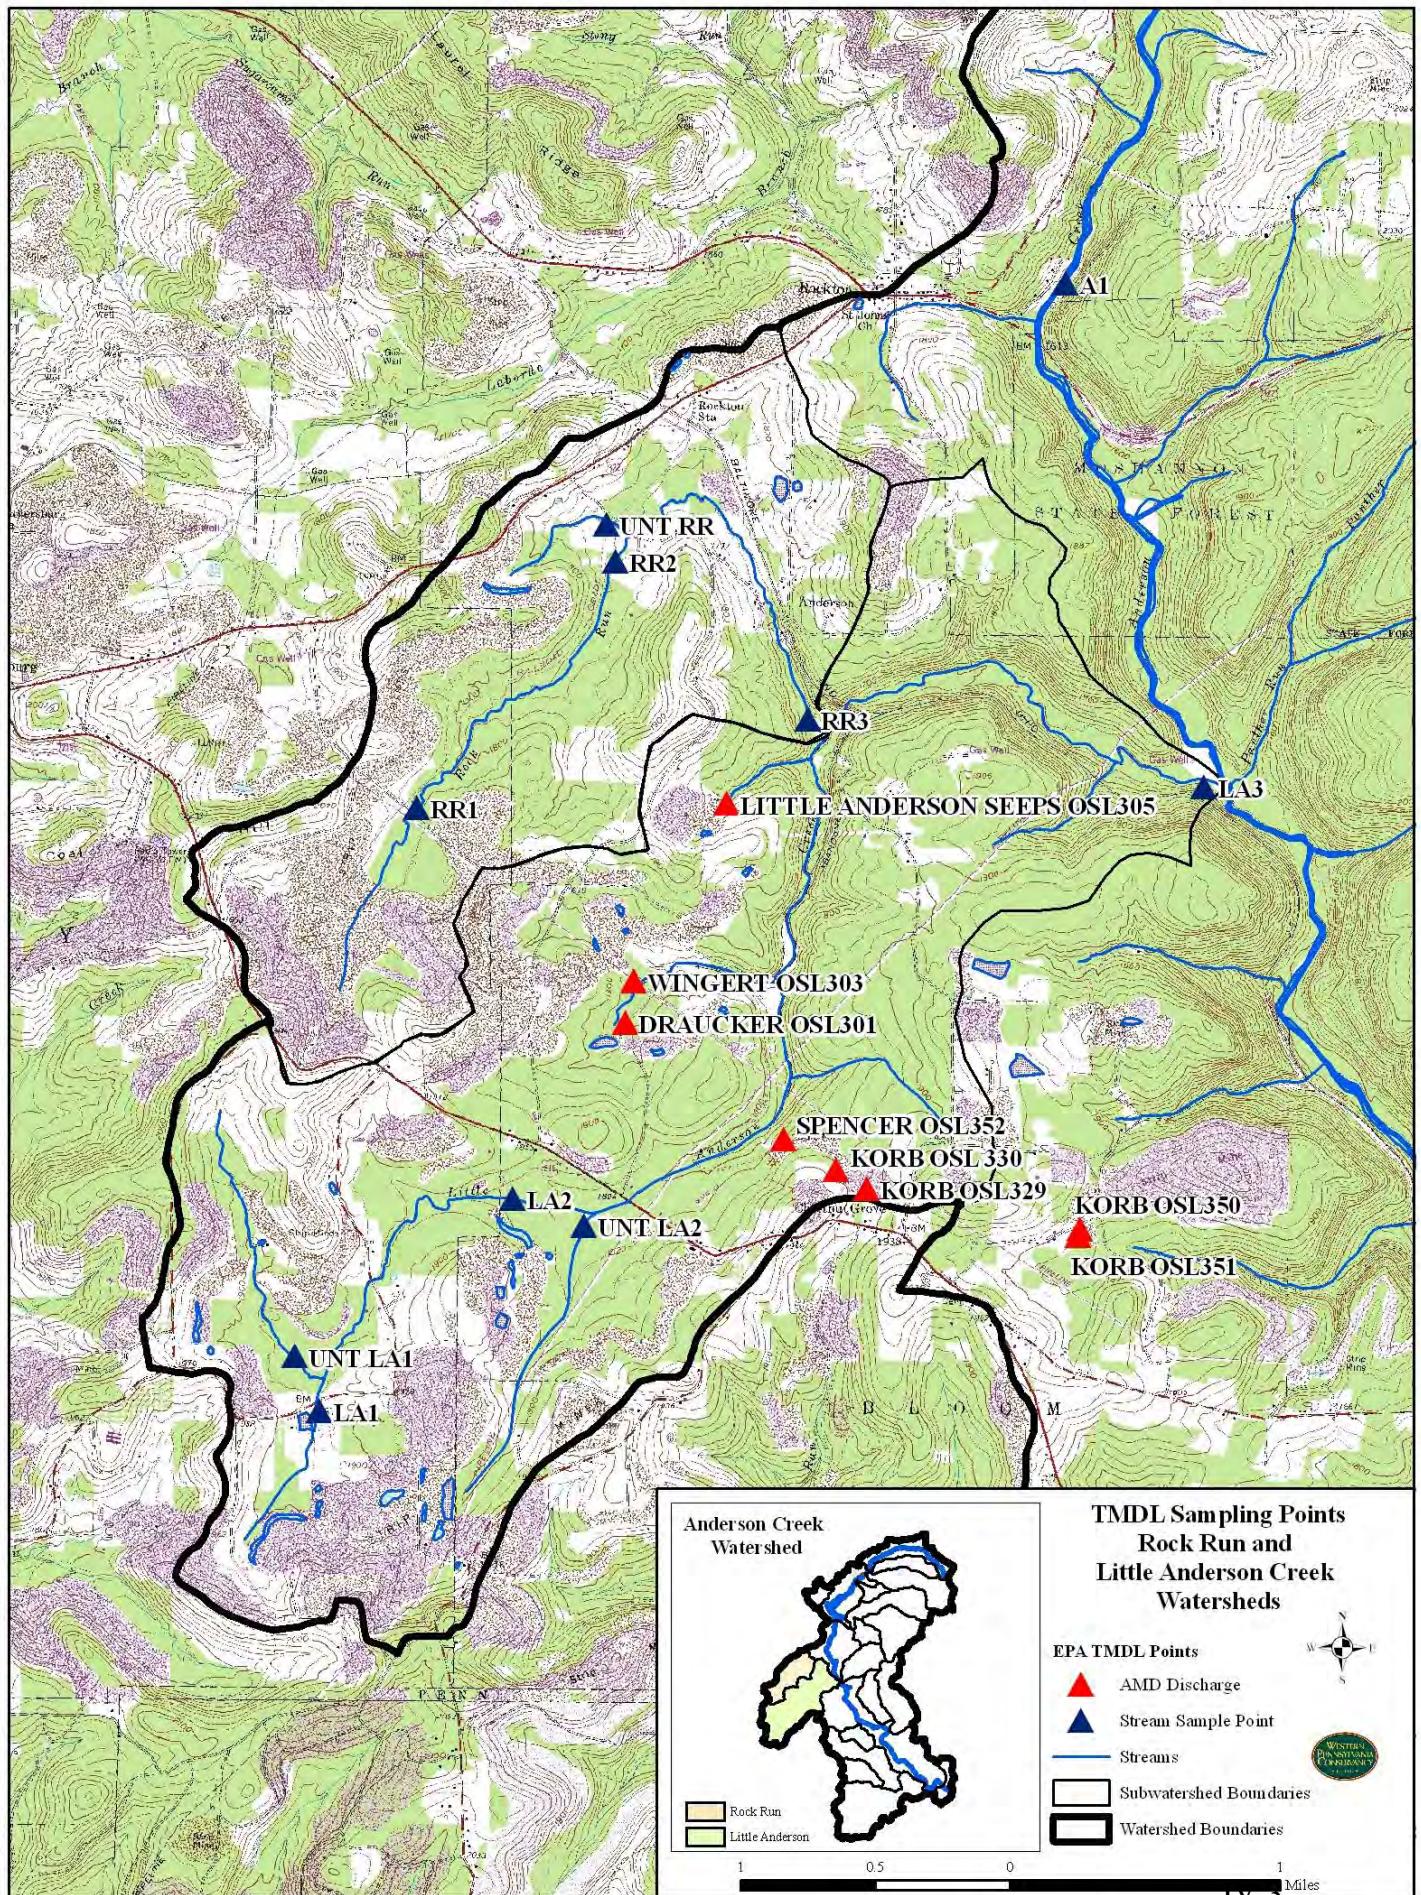
#### **Little Anderson above TMDL point LA1**

This stream segment represents the absolute headwaters of Little Anderson Creek. It is located approximately six miles upstream from the mouth of Little Anderson Creek and is about 4,000 feet in length. The stream is low gradient and is characterized by very large wetland areas surrounding the entire segment.

Most of the area above the segment, which is located south of the bridge on State Route (SR) 4010, has been surface mined and reclaimed, though some unreclaimed or poorly reclaimed land is present. Some of the areas have been remined. A very large wetland area is located within this section of the stream. According to the landowner (Mr. Peterman) where the segment is located, the wetland area was once farmed but is now saturated with groundwater, rendering farming impossible. There is one area in the upper end, below Shaffer Road and above the Peterman farm along SR 4010 that had low field pH readings, indicating acidic conditions. Vegetation in the area was obviously affected by the acidic water. The seep zone was visually estimated to have a total flow of approximately 15 gallons per minute (gpm). An accurate measured reading could not be collected due to the diffuse nature of the seeps. This site clearly had negative impacts locally, but there was enough net alkaline groundwater (albeit polluted with iron) that it was neutralized after a fairly short distance. Because it is an acidic discharge, neutralization of the acidic discharge would likely improve the water quality in the stream.

Most of the surface water within this section of the stream has a field pH above 6.0, but is polluted by iron. Elevated levels of iron also likely pollute groundwater, as iron staining is visible throughout the wetland in many areas where no flowing surface water exists. Iron was also observed being mobilized while walking in the wetlands, during the visual assessment.

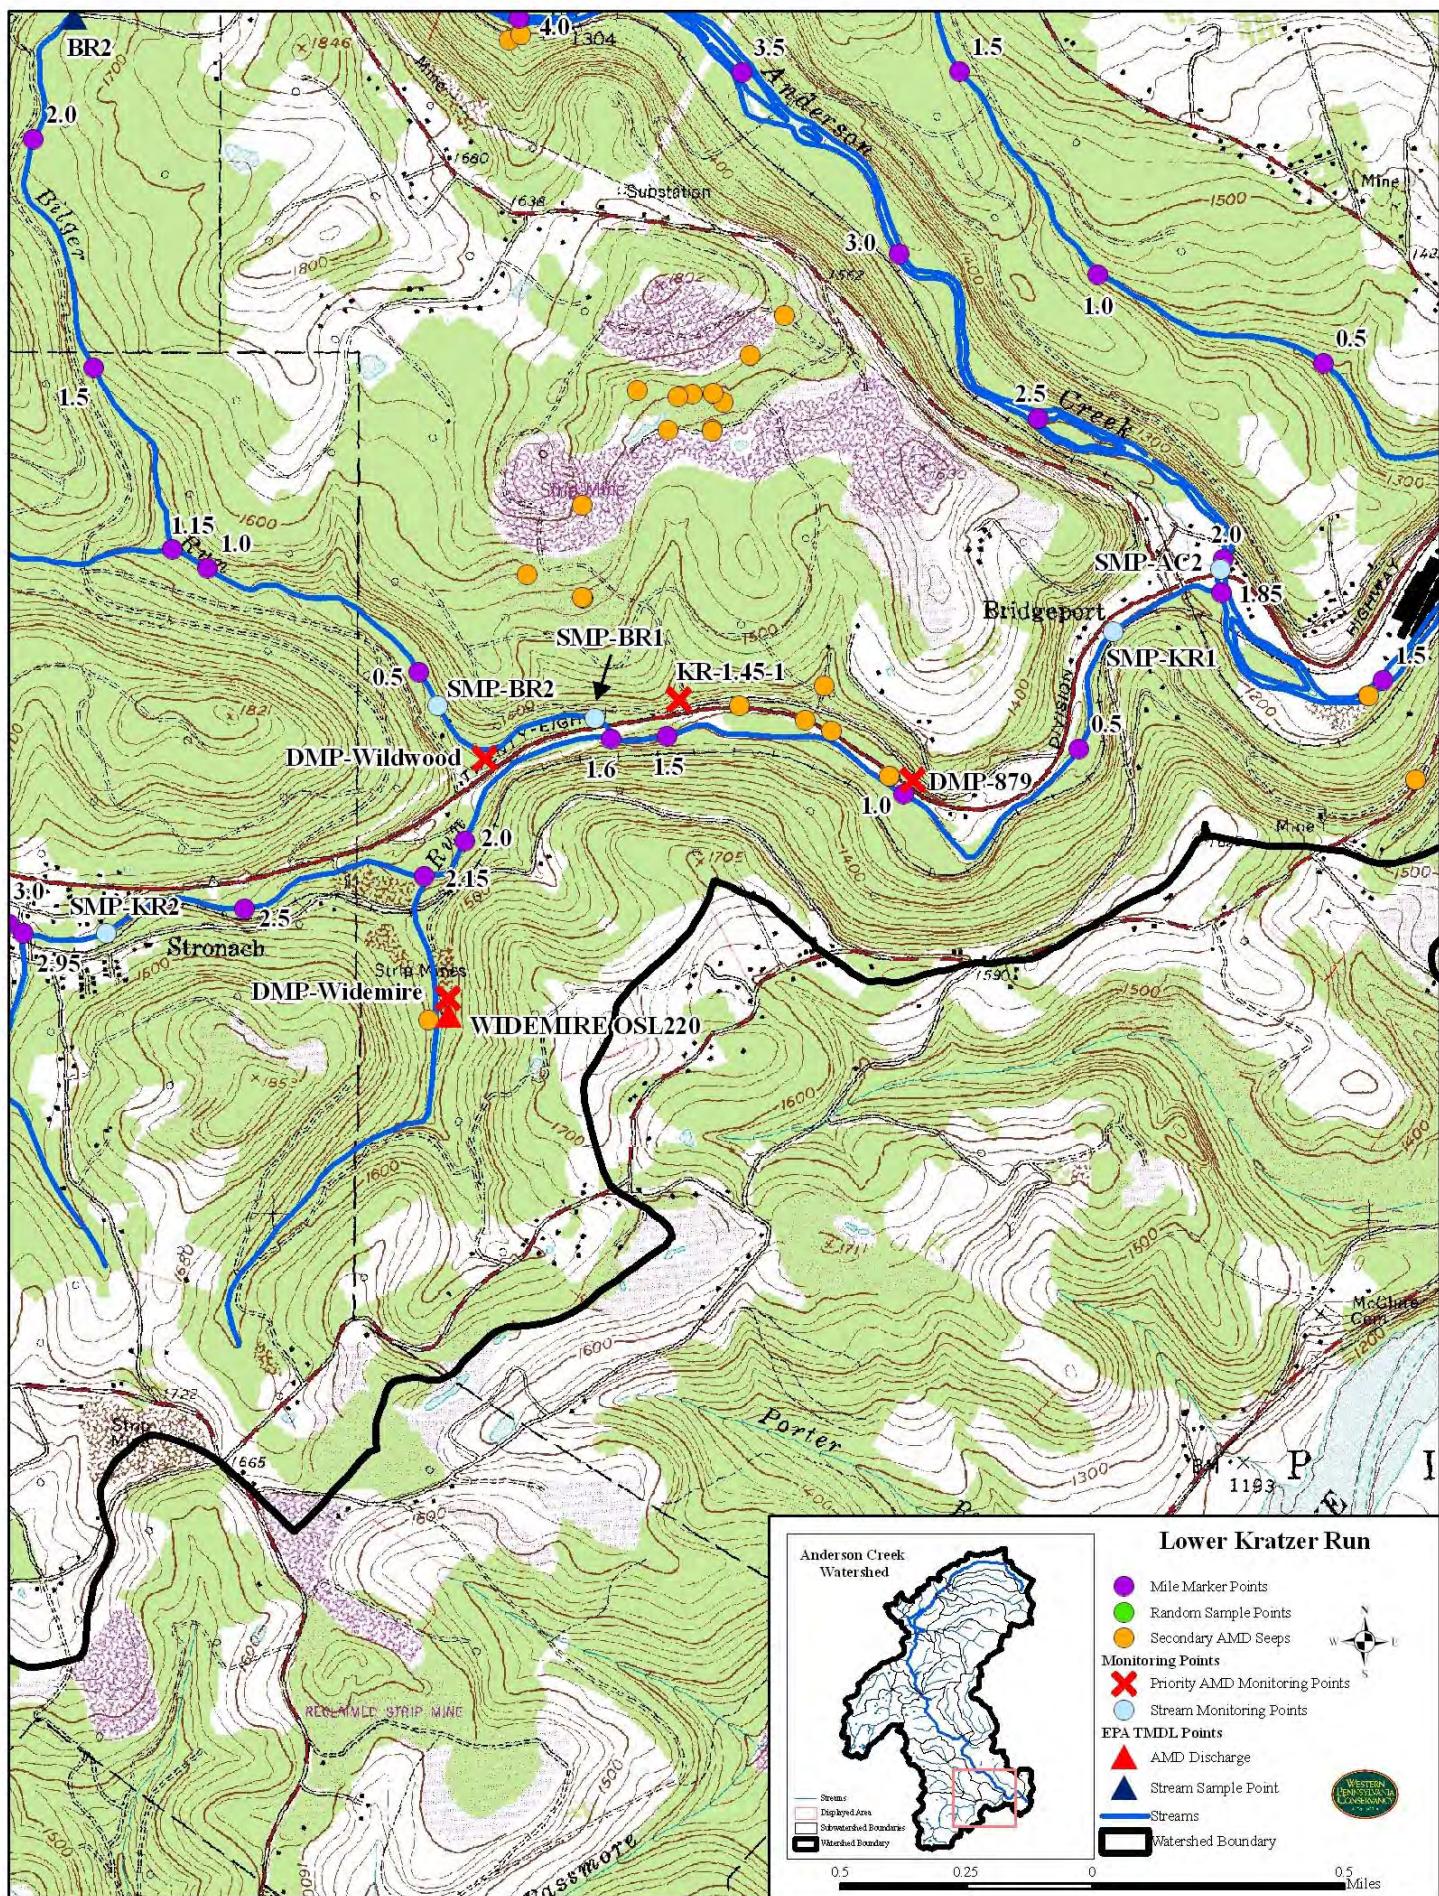
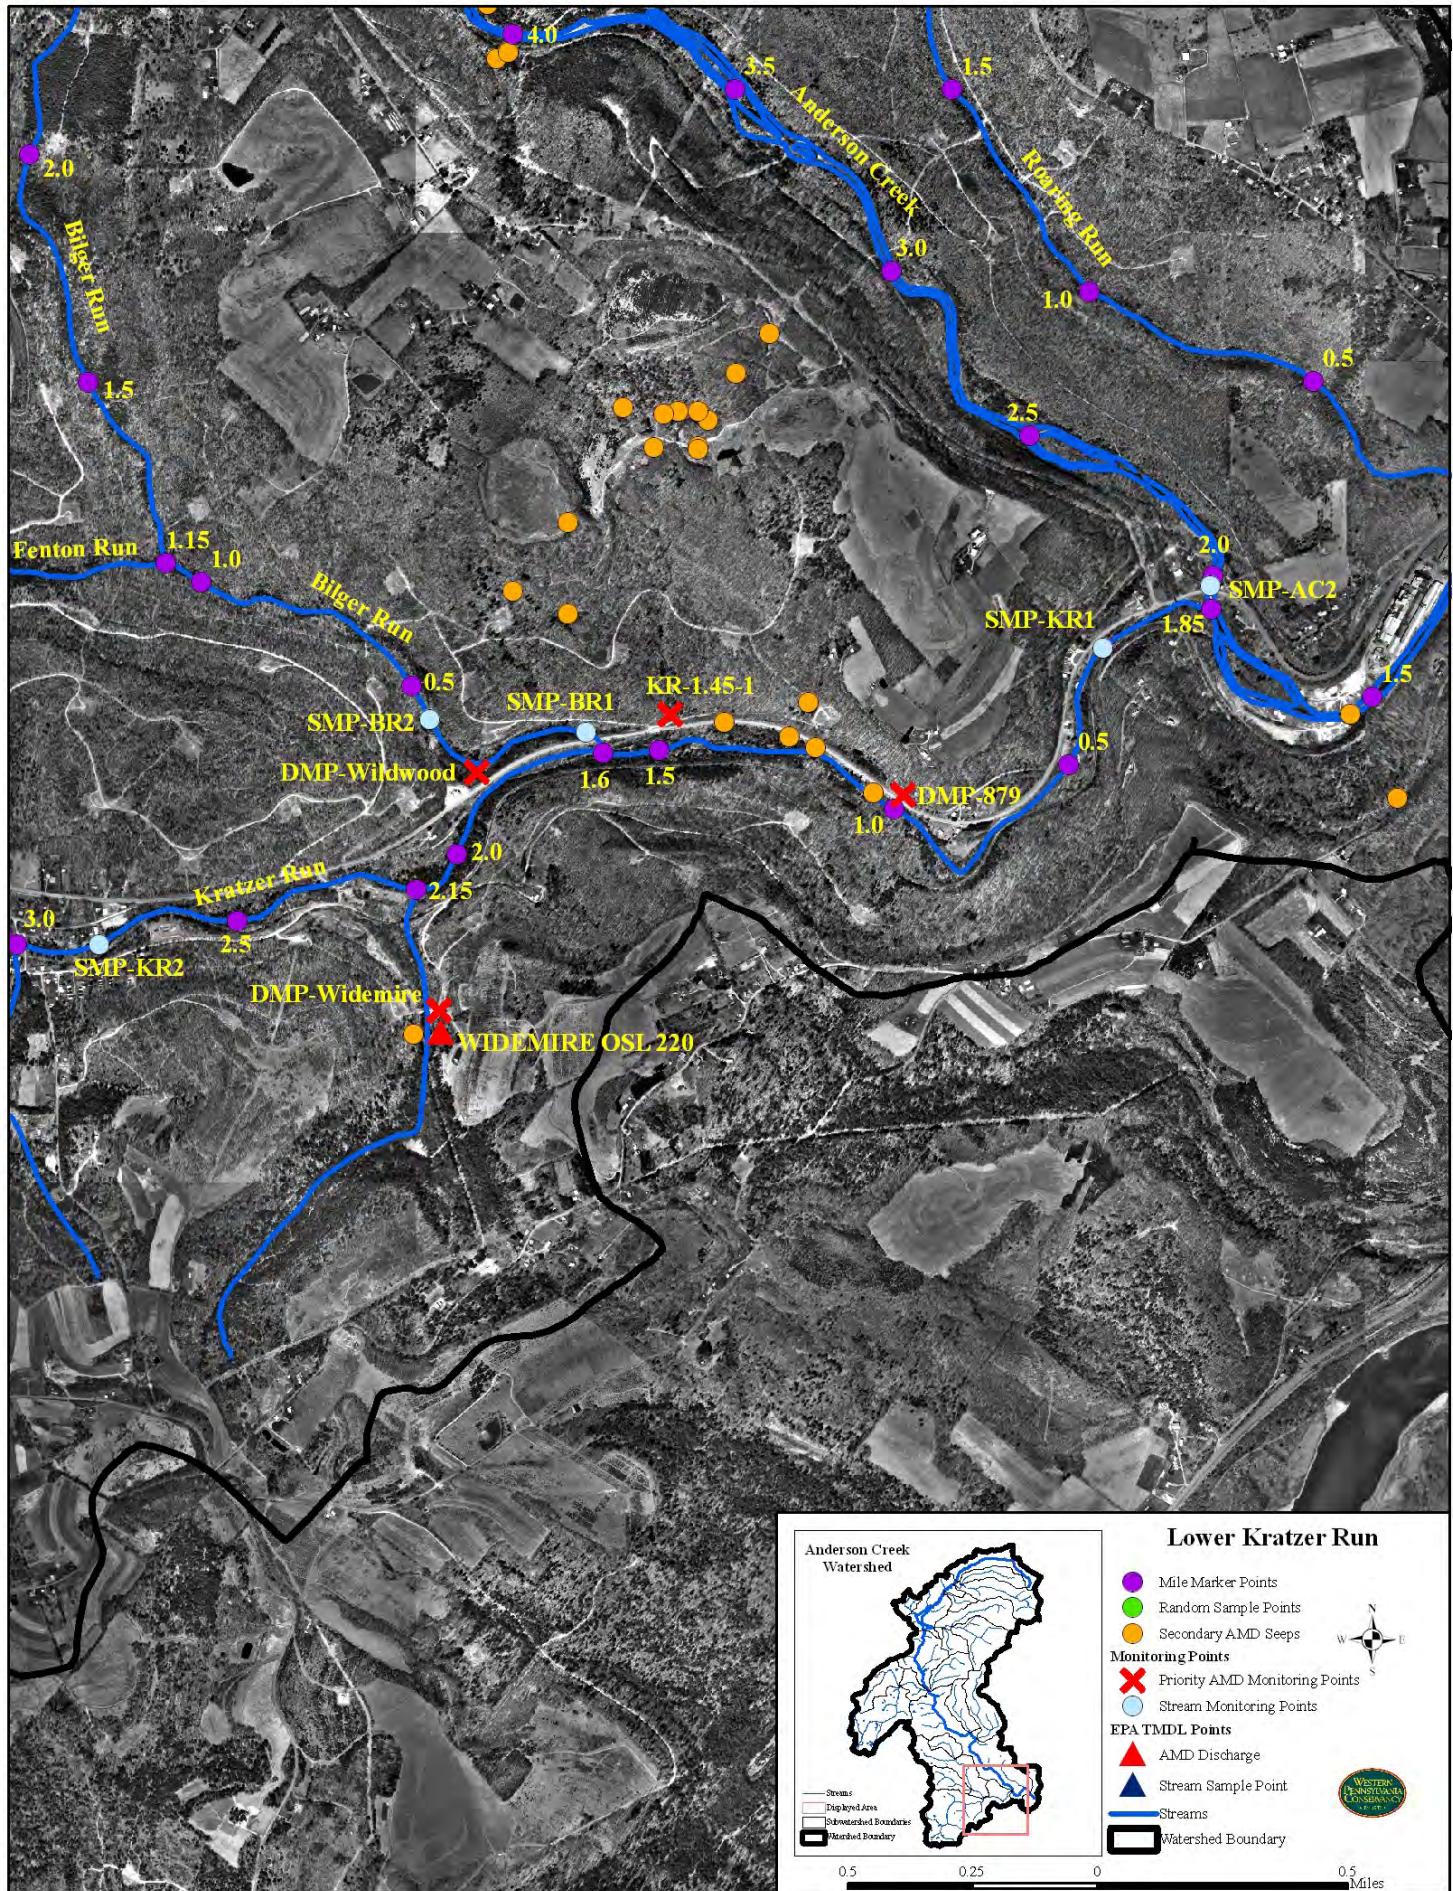
*The Widemire Discharge pollutes an unnamed tributary to Kratzer Run (UNT-KR2.15) with acid and aluminum.*

Aluminum and acidity levels are of most concern. During the study period, its flows fluctuated between 50 and 250 gpm. The TMDL for Widemire Discharge requires that a load allocation be made for OSL 220 [DMP-Widemire] for total iron and acidity (SRBC 2004).

There were fewer manganese and aluminum data than necessary for this discharge to conduct Monte Carlo analysis; therefore, they were not evaluated for this TMDL. However, the observations for manganese and aluminum in the downstream segments of an unnamed tributary to Kratzer Run indicate that they also may be violating water quality standards. It is assumed that BMPs used to reduce iron loads in this reach also would reduce the amount of manganese and aluminum (SRBC 2004).
